Data Acquisition for a Bridge Collapse Test

Kurt Veggeberg, Business, Development Manager (kurt.veggeberg@ni.com)
National Instruments, 11500 N. Mopac C, Austin, TX 78759

ABSTRACT - Researchers at the Ferguson Structural Engineering Laboratory successfully collapsed a 120-foot bridge with an intentionally fractured girder to study behavior and safety. It required three rounds of testing before the damaged bridge finally failed under an applied load of more than 360,000 pounds. The bridge, tested to determine its vulnerability to collapse following the fracture of a girder, withstood about 4.5 times the maximum legal truck load. Nearly 300 strain gauges and displacement transducers as well as recorded how the bridge reacted in this extremely damaged condition to incrementally increasing loads during the two rounds of testing. Wireless data acquisition modules were used to monitor the condition of cranes used to apply loads. This presentation is an overview of the methodology used to determine whether or not this design is fracture critical as is commonly assumed.

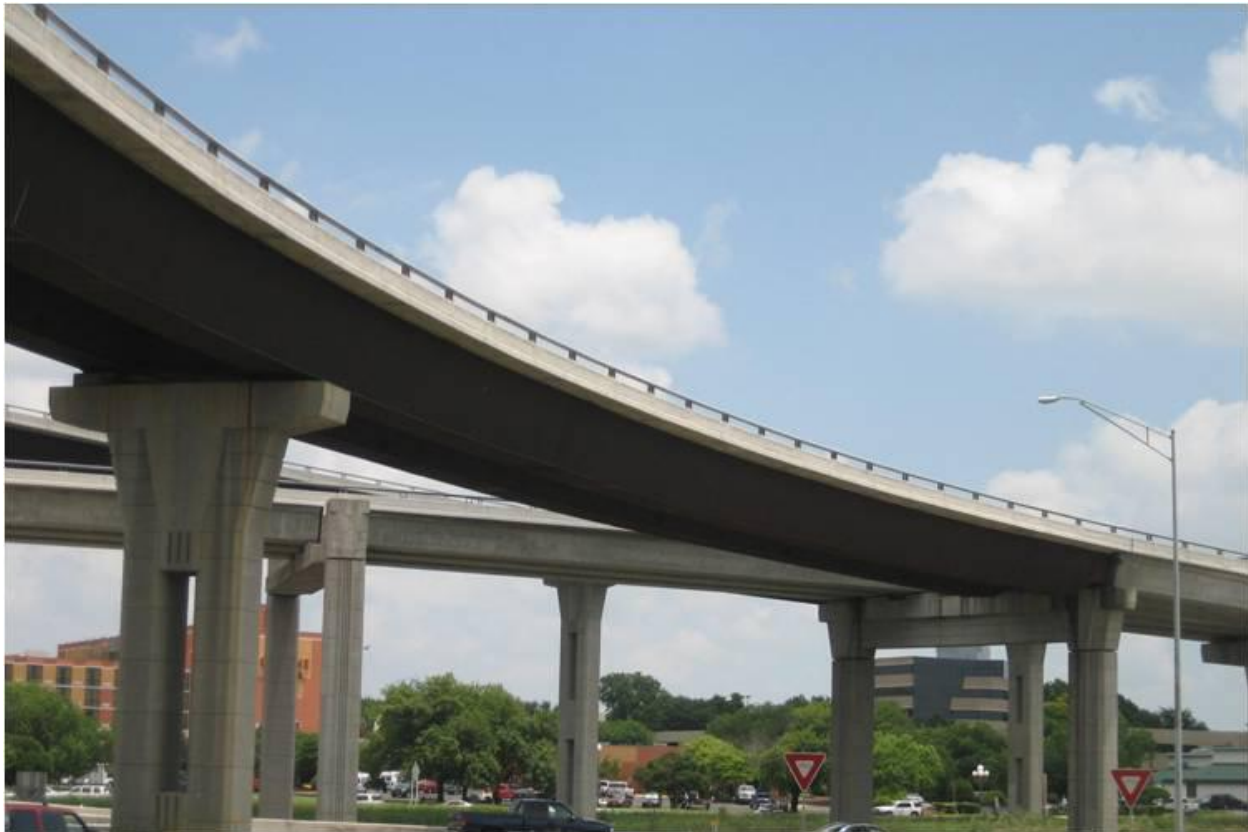
Figure 1. Twin box-girder steel bridge (Ferguson Structural Engineering Laboratory)

The Texas Department of Transportation and the Federal Highway Administration funded a large-scale research project through the Ferguson Structural Engineering Laboratory at the University of Texas to develop methods for evaluating the redundancy of fracture critical steel bridges. (Figure 1) As part of the research project, a full-scale twin box-girder steel bridge representative of fracture critical bridges in Texas was decommissioned from the highway system in Houston, rebuilt at Ferguson Lab, and prepared for testing. (Figure 2)

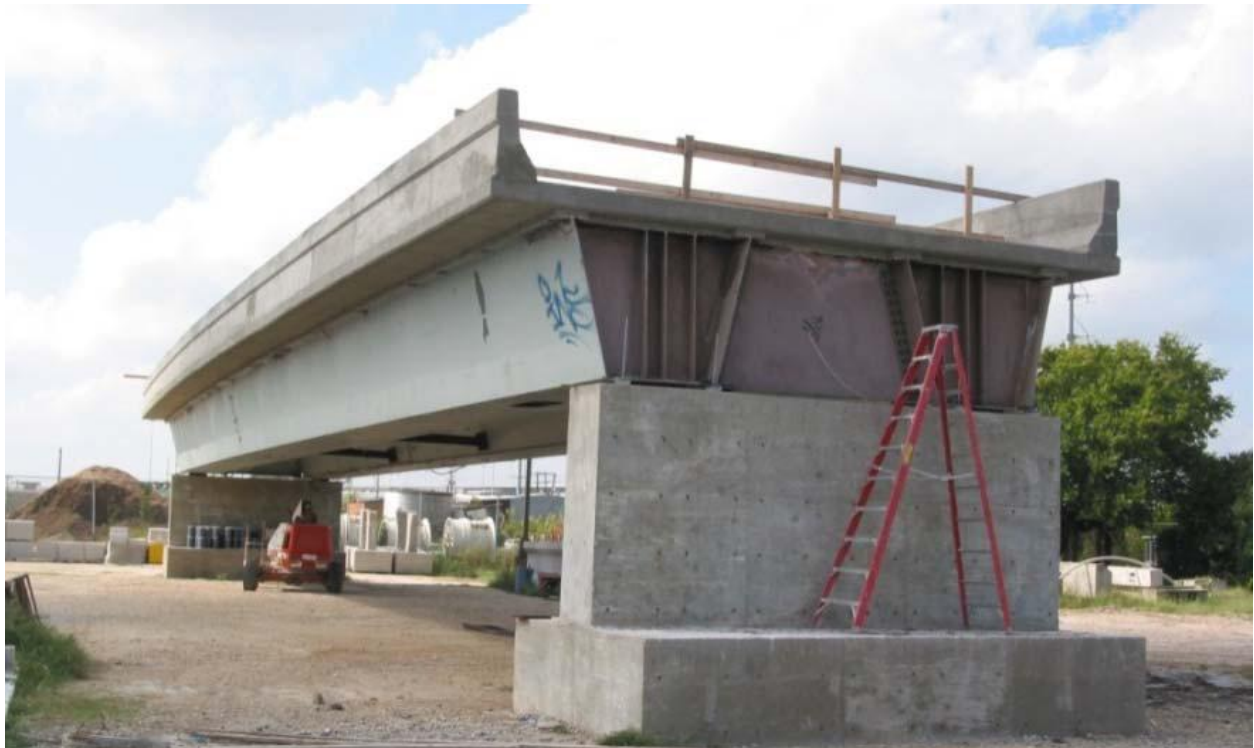
Figure 2. Test Bridge at Ferguson Structural Engineering Laboratory

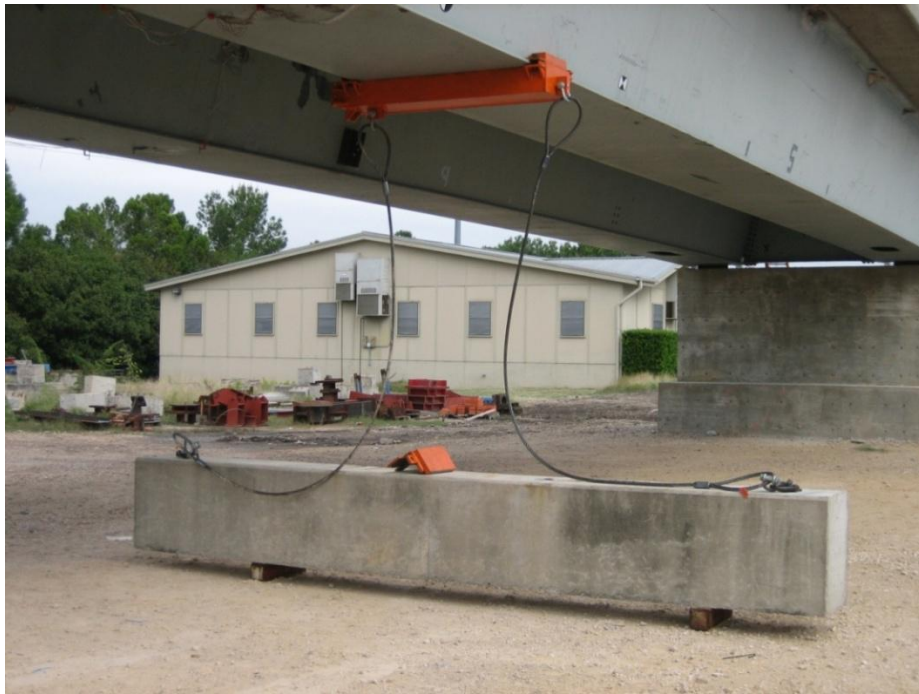
Figure 3. Explosive shaped charge applied to test bridge

The first test on October 21, 2006 used explosives to induce a complete fracture in one of the bridge's bottom flanges. (Figure 3) Despite having a load equivalent to a 76,000 lb. truck positioned directly above the mid-span fracture location, the fracture did not propagate into the webs of the girder, minimal deflections were observed, and there was no significant degradation in the capacity of the structure despite the loss of a fracture critical element. (Figure 4)

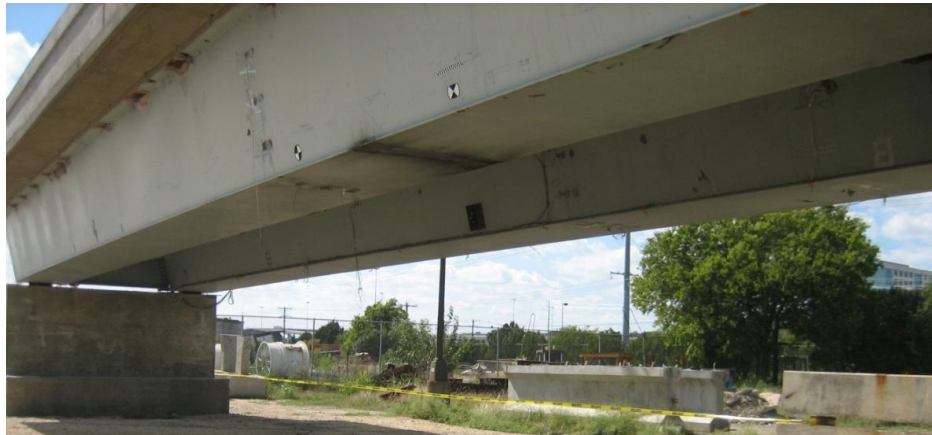
Figure 4. Bridge fracture after explosion.

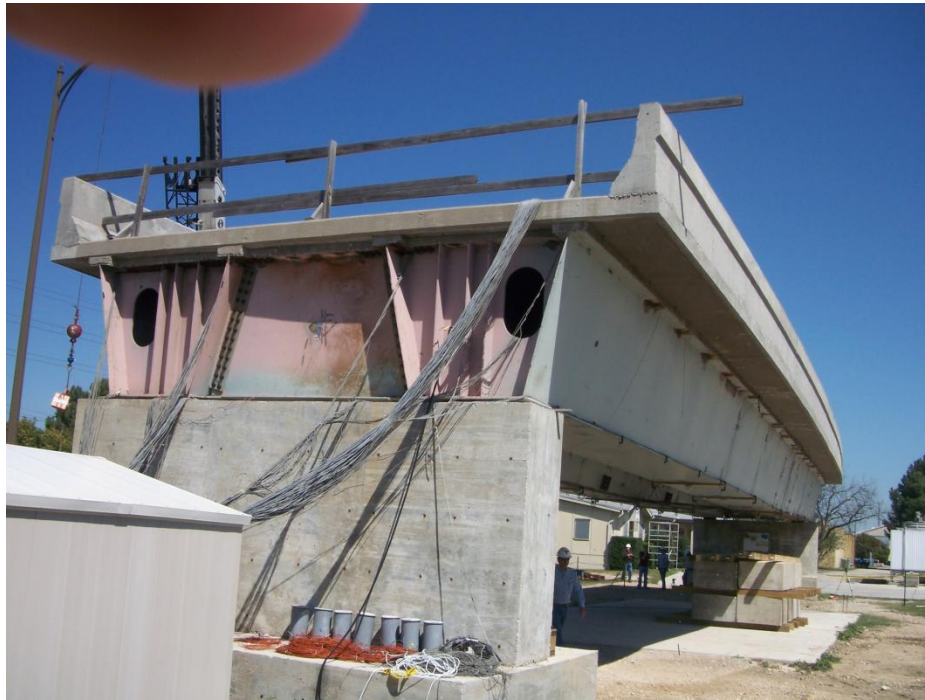
Figure 5. Wires connected to instrumentation

Wires connected to each piece of instrumentation were run to the southern end of the bridge where a small hut housed all of the data-acquisition equipment (Figure 5). For the first full-scale test, a high-speed data-acquisition system was configured for all 127 channels of instrumentation (Figure 6). Because the loading and subsequent bridge response was expected to be dynamic, it was important to sample the data rapidly, accurately, and in a synchronized manner. The system used for the test employed equipment from National Instruments and was set up to sample data simultaneously from all 127 channels, 1000 times each second. The wires from the 127 instrumentation channels were connected into sixteen National Instruments SCXI-1314 8-channel terminal blocks. Each terminal block hooked into its own SCXI-1520 8-channel universal strain module. Two SCXI-1001 12-slot chassis were used to

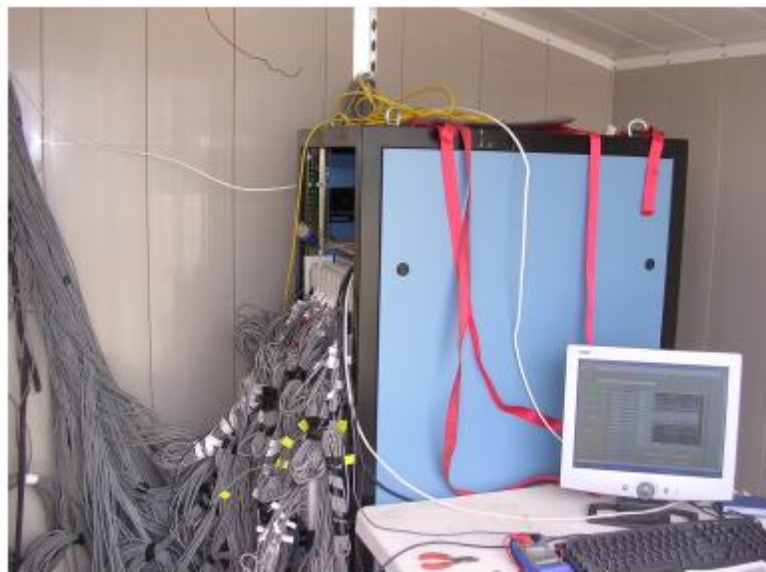
Figure 6. Data Acquisition System

house the sixteen modules.. The two chassis were connected through a PC that was equipped with a National Instruments PCI-6250 data acquisition card. LabVIEW was used on the PC to view and organize the incoming data.

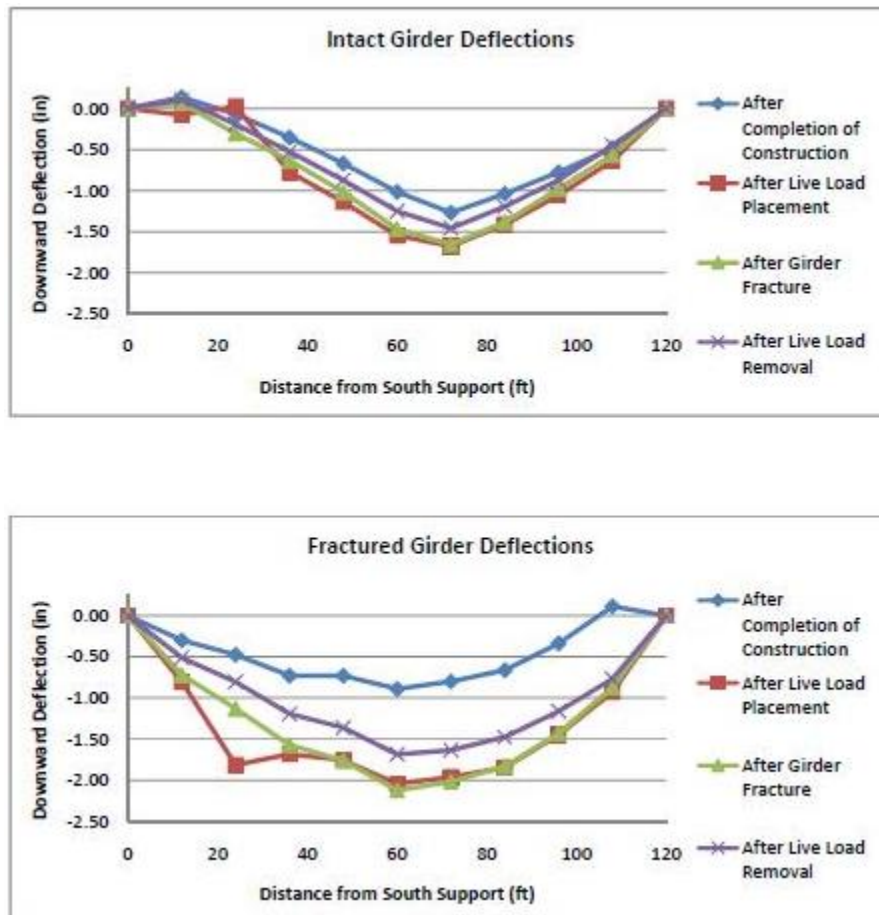
Figure 7. Girder deflections for test 1.

The static deflections of the intact and fractured girders were relatively small. The mid-span of the intact girder deflected downward 0.5 in. under the initial application of the simulated truck live load, then deflected an imperceptible amount following the fracture of the opposite girder, and finally rebounded 0.25 in. when the live load was released. The deflection of the mid-span of the fractured girder follows a similar pattern. It first deflected downward 1.25 in. under the live load, then deflected a very small amount following the fracture of its own bottom flange, and finally rebounded 0.4 in. when the live load was released. A total deflection of 1 in. 2 in. across a 120 ft. span is considered small. The bridge performed exceedingly well relative to the AASHTO fracture critical designation. (Figure 7)

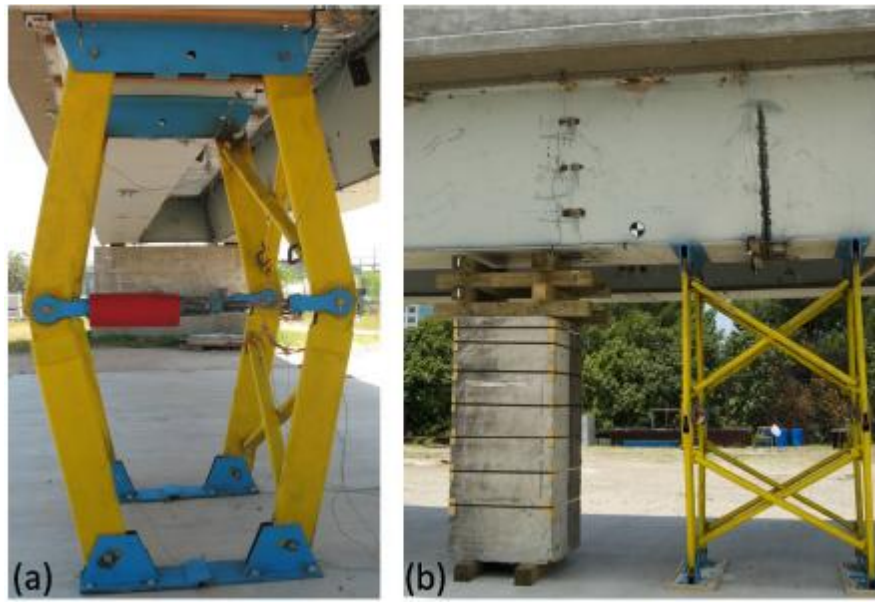
Figure 8. Scissor jack system used to shore up bridge for test 2

The second full-scale test was designed to produce a dynamic response of the test bridge after it had been held in position while damage comparable to what it would have sustained in the event of an actual fracture was induced. Preparations for this test were extensive. A scissor-jack system was designed, constructed, and installed to raise the mid-span of the fractured girder 0.25 in. and support it while damage was induced on the bridge. (Figure 8)

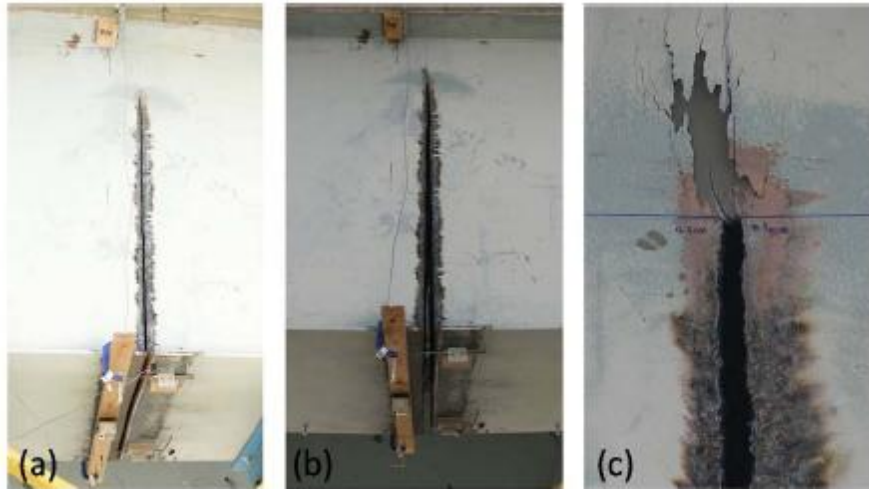
Figure 9. Fractures after release in test 2.

The second full-scale test was executed and successfully loaded the test-bridge after it sustained a full-depth fracture in one of its girders. The downward deflection of the fractured girder was as much as 7 in. in locations, and the bridge sustained significant damage to the shear stud connections between the top flanges of the fractured girder and the concrete deck. (Figures 9 and 10) Despite the displacements and damage sustained, the test-bridge resisted collapse, maintaining complete serviceability in its fractured state with the design truck load positioned directly above the fracture location.

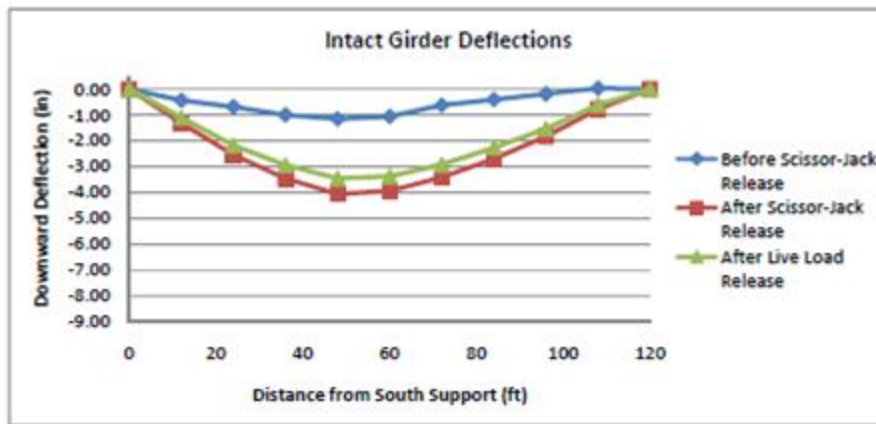
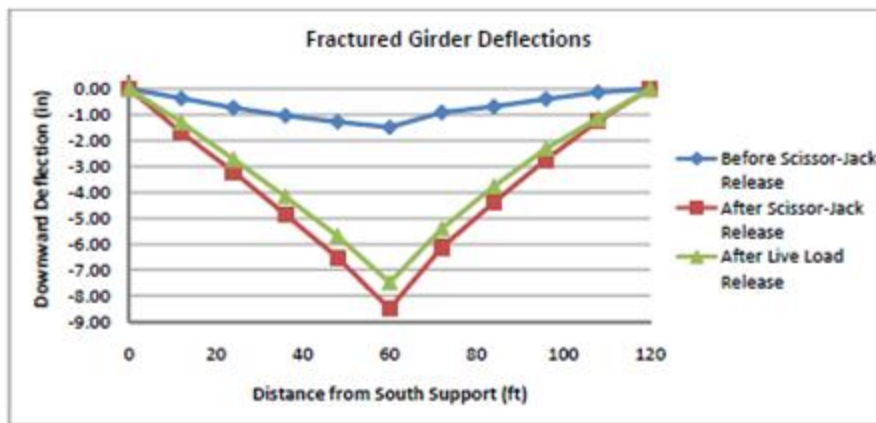
Figure 10. Girder deflections in second full-scale test.

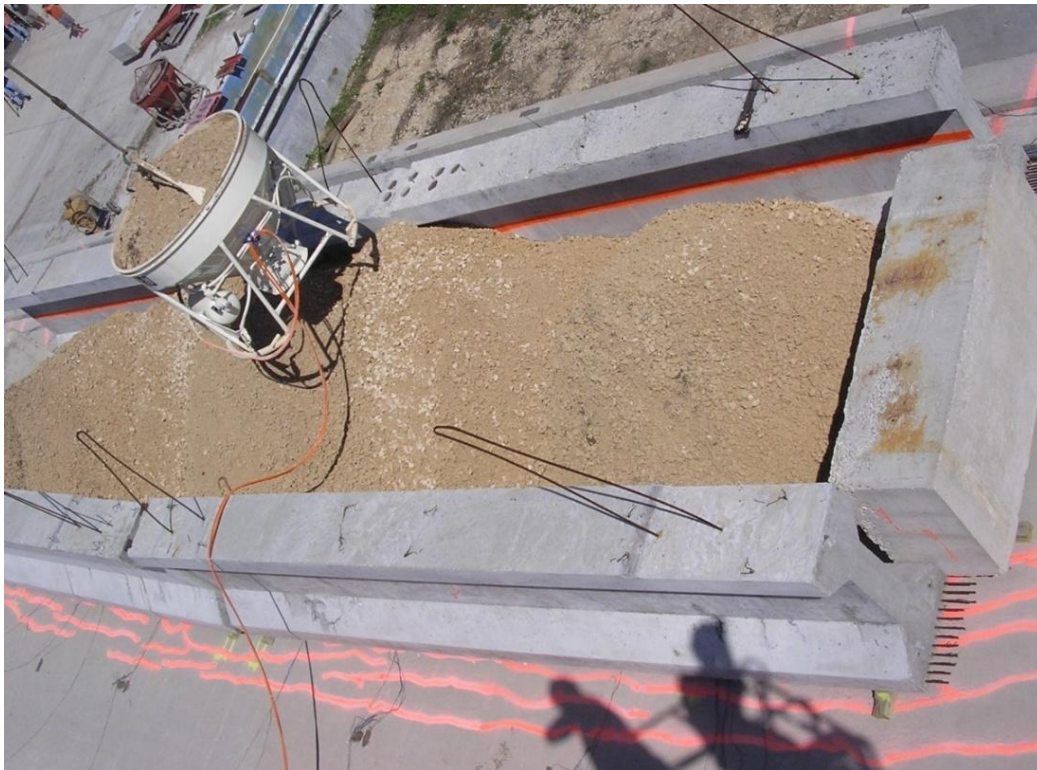
Figure 11. Loading the bridge with road base.

After placing the concrete girders on the bridge deck, additional load was applied by incrementally dumping material into and eventually around the bin. Road base was chosen as the loading material for its ease of acquisition, low cost, and relatively high density. (Figures 11 - 15)

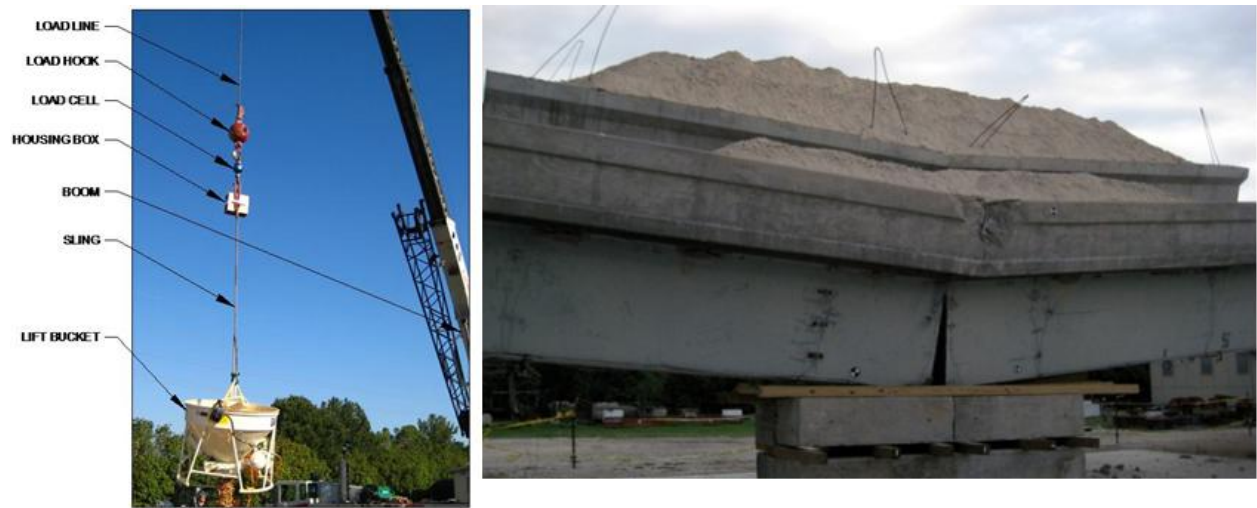
Figure 12. Bridge loaded to collapse.

After three days of loading 1500 pounds of road fill at a time, large portions of concrete at the mid-span expansion joint of the exterior railing began to spill when the total load applied to the bridge reached 360,200 lbs. After the onset of major material losses, three additional lift bucket loads were placed on the bridge before the bridge came to rest on the concrete bed below. As the load applied to the bridge increased over the course of the experiment, the bridge components experienced a series of failures. Following these intermediate failures, the bridge was able to redistribute the applied loads, suggesting the contribution of redundant load paths in maintaining equilibrium of the bridge in its progressively damaged state. (Figure 16)

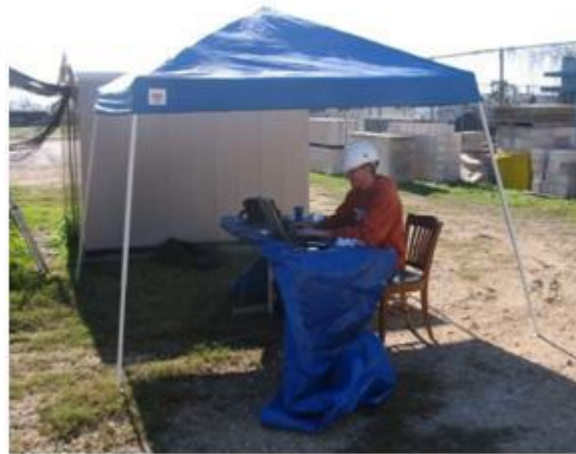
Figure 13. Remote load cell monitoring.

Obtaining a lifted weight measurement for each crane pass, from the placement of the concrete girders through the placement of each bucket of the road base, was critical. To measure the weights quickly and easily, a load-cell was attached to the crane load line above the lift bucket. A Wi-Fi transmitter was

connected to the load cell so that the load data could be easily read and recorded from across the work-site.

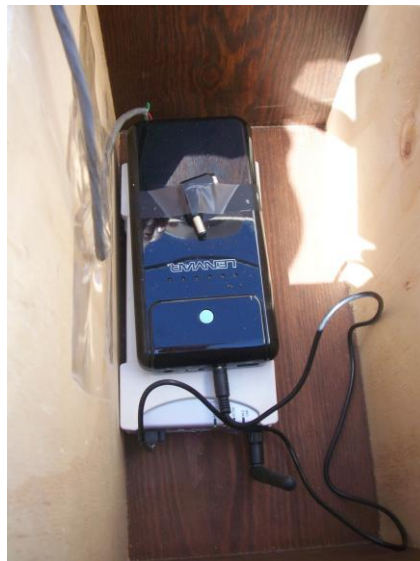
Figure 14. Wi-Fi DAQ module with battery in housing box for measuring load cell

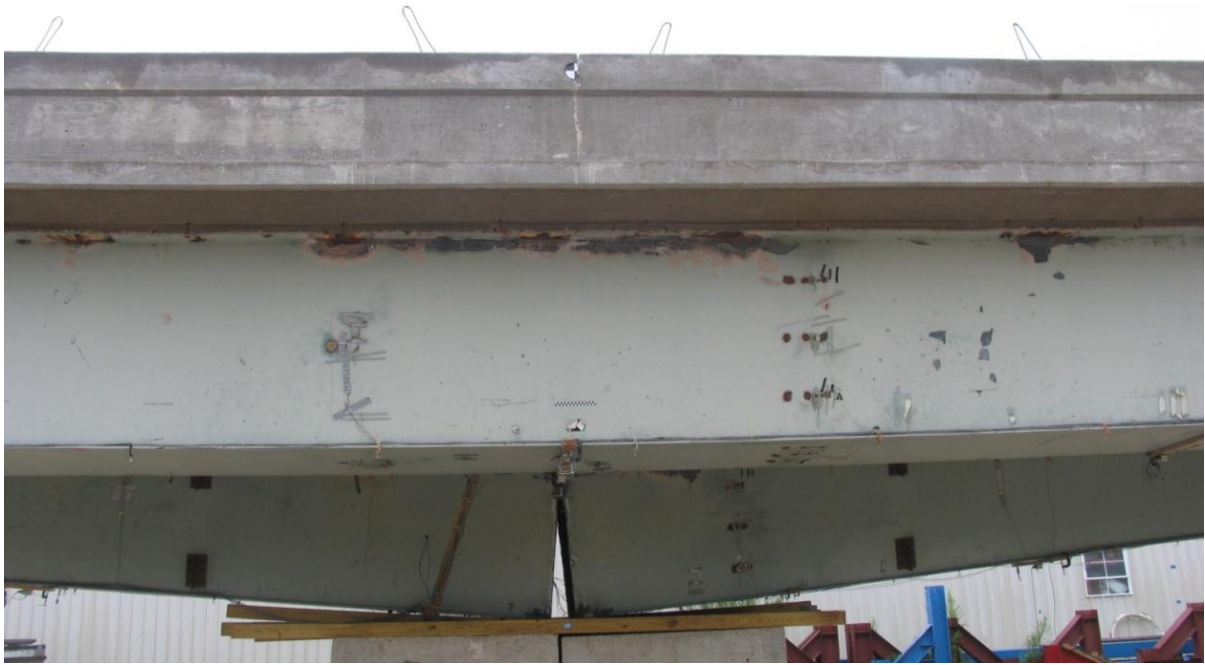
Figure 15. Side view of intact girder.

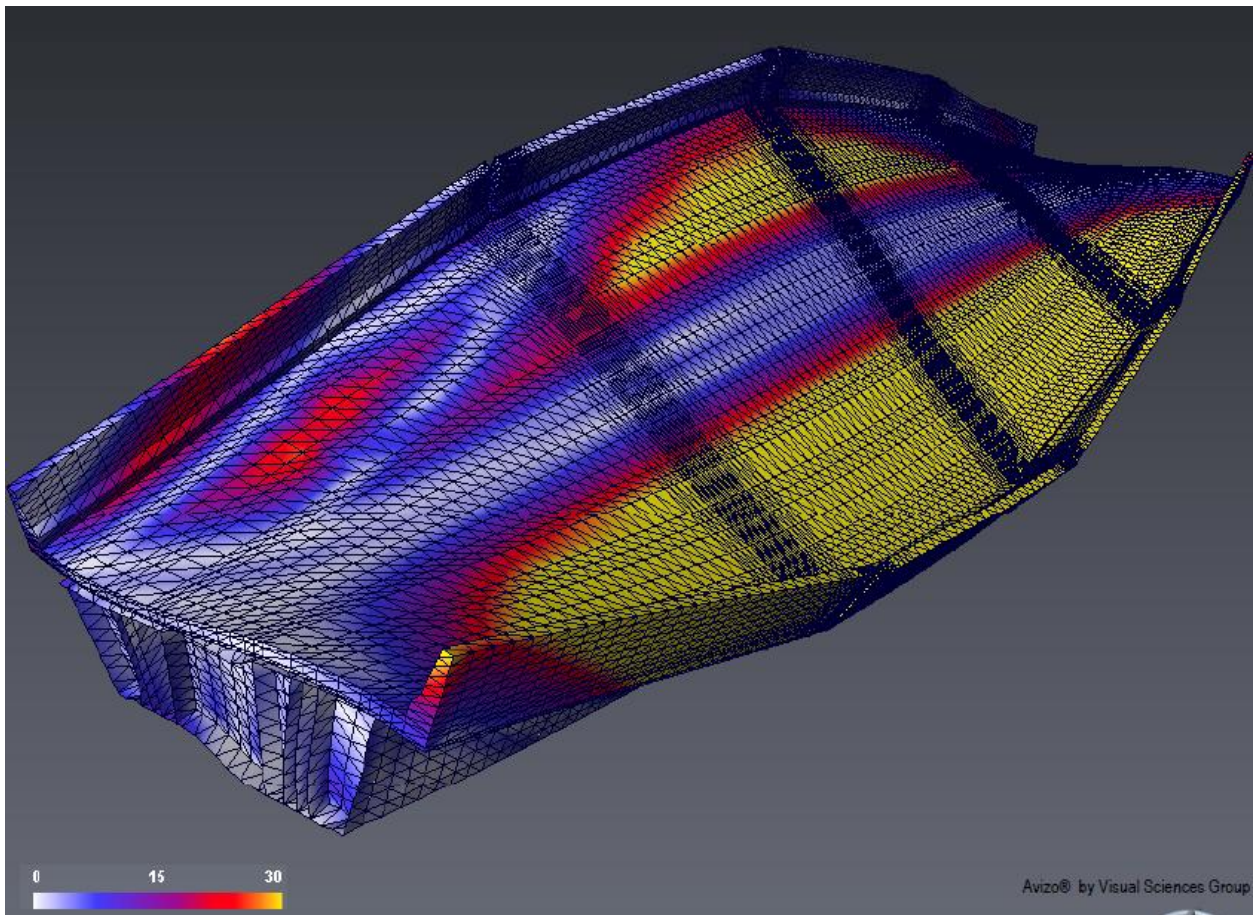
Figure 16. Bridge Model Validation visualization with Avizo
